Winfield Locks

Failed Embedded Miter Gate Anchorage

Feb 2015

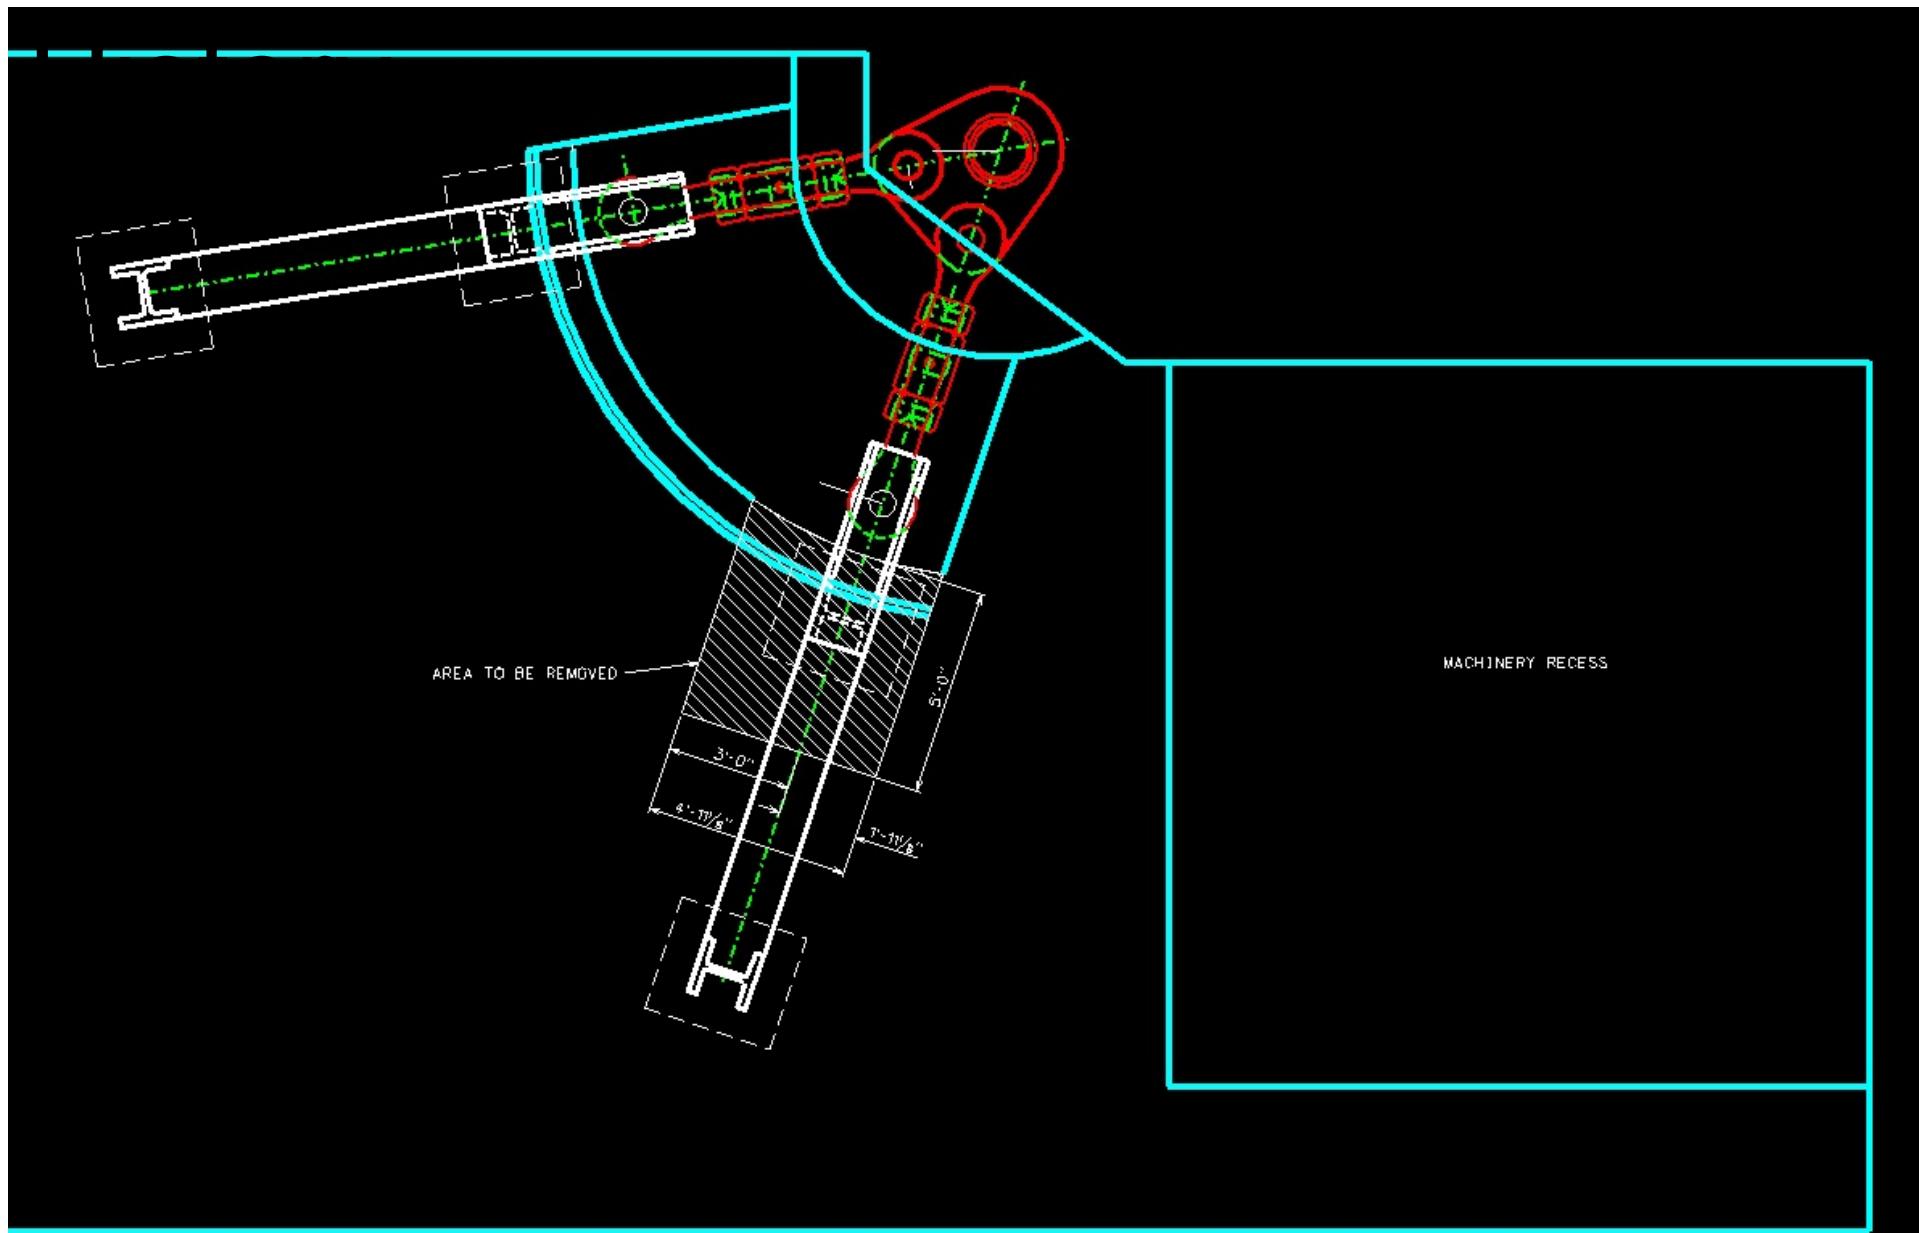
PLAN OF UPPER RIVER WALL MITER GATE ANCHORAGE

- May 2014 LRL fleet crew removed concrete to expose the top of the embedded anchorage.

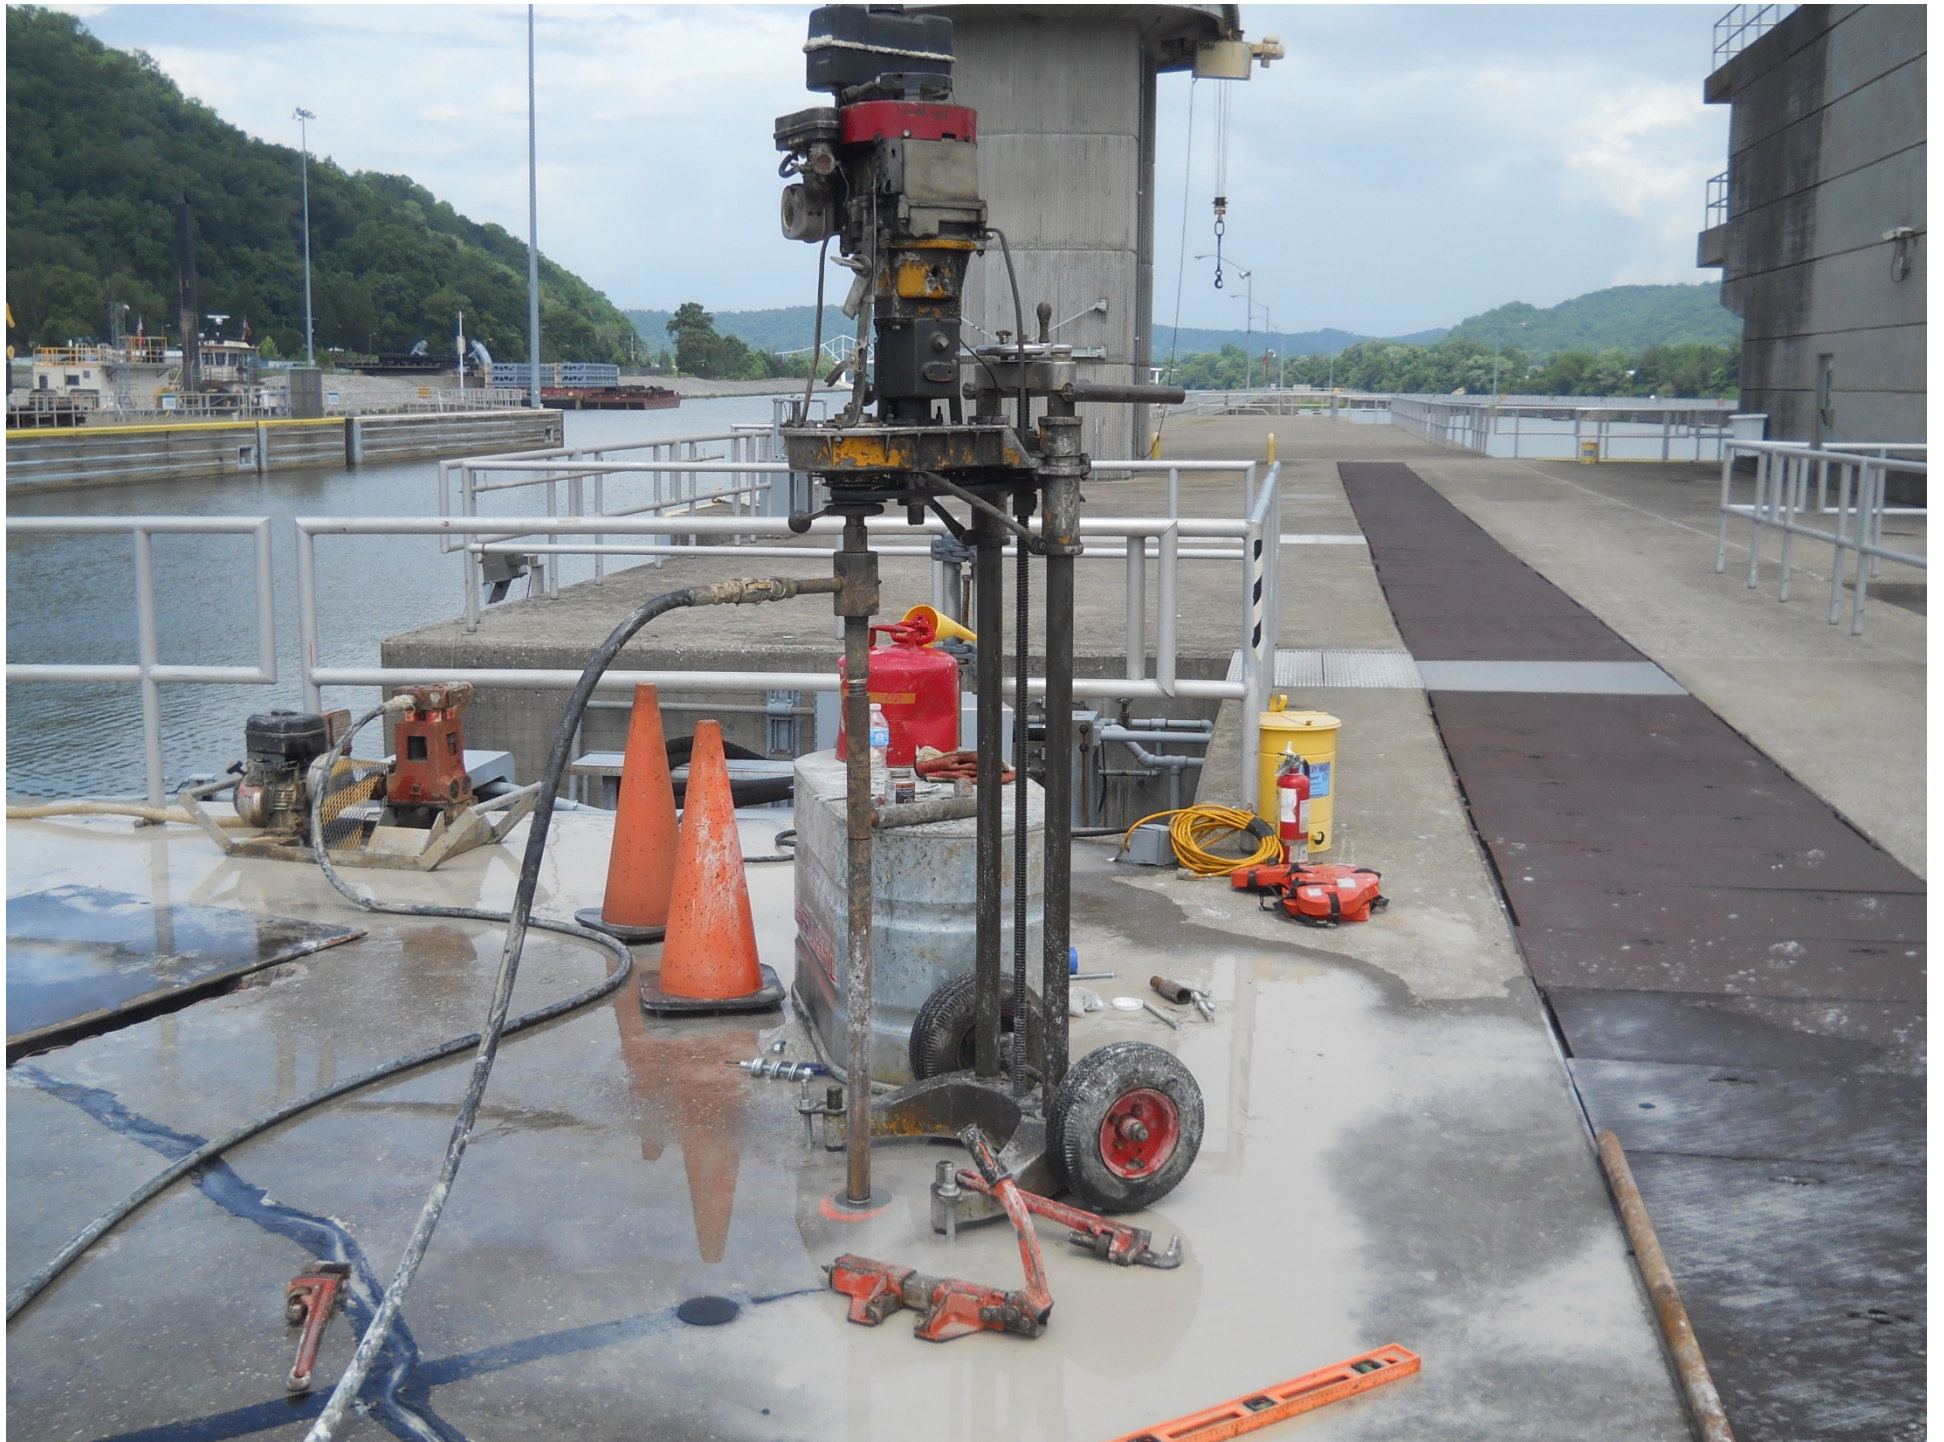
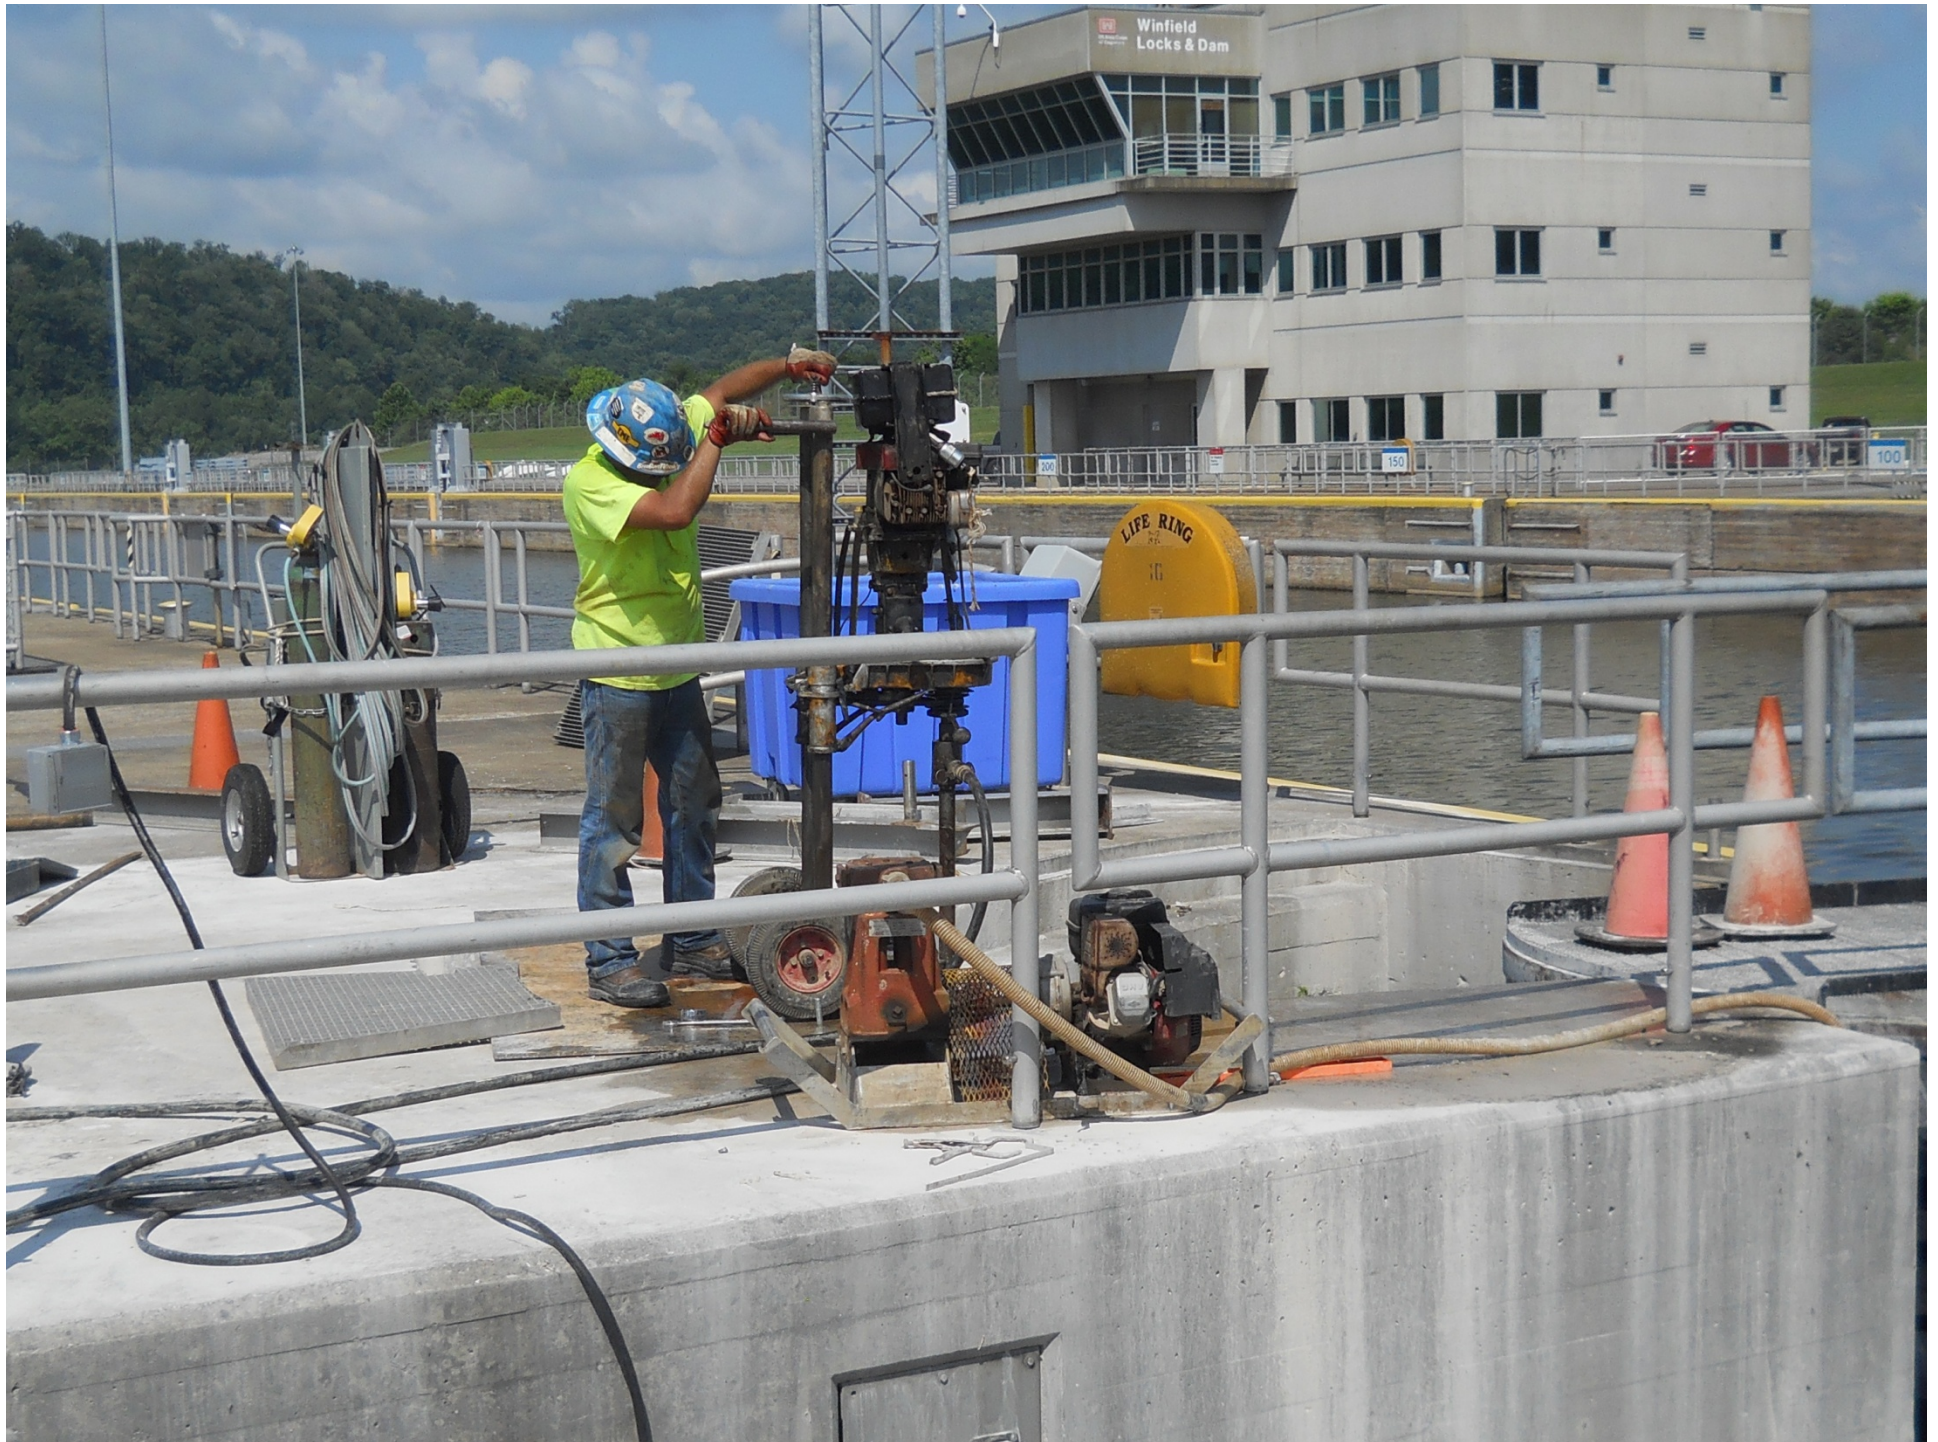
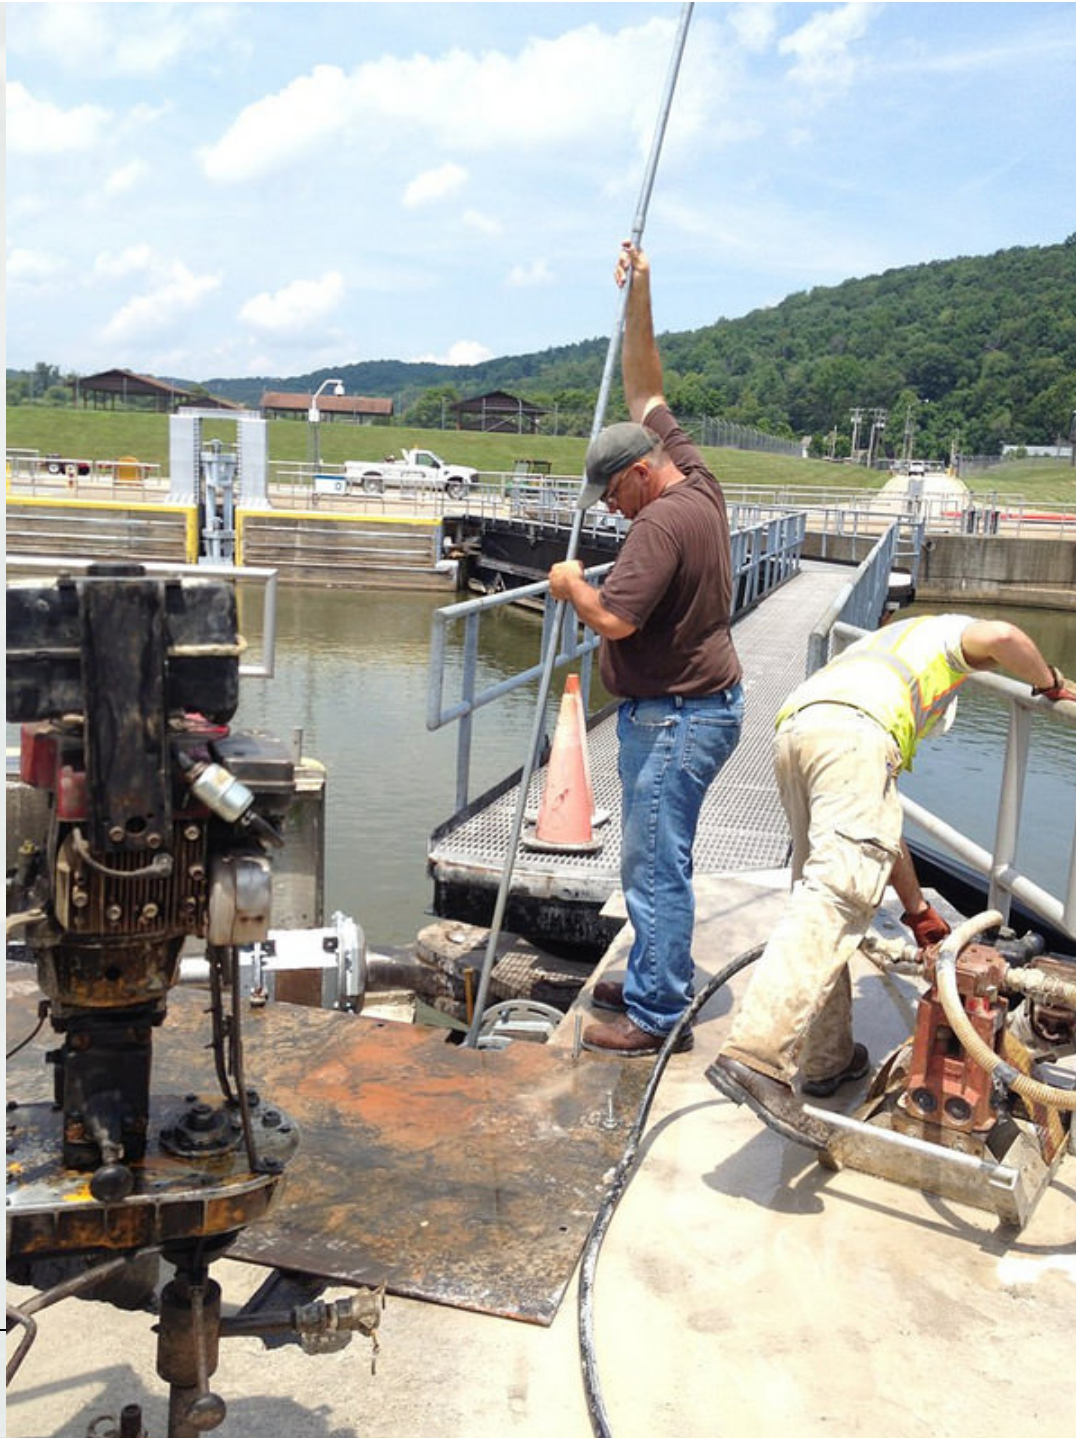
- June 2014 – a contractor drilled holes vertically through the lock wall to the anchorage base to measure movement on front and rear of the embedded anchorage

Front of
Anchorage
movement was
minimal- less
than 1/16"

Rear of
Anchorage
movement was
significant-
almost exactly 1"
